AZUMAYA PROGRESS – MARCH 2007

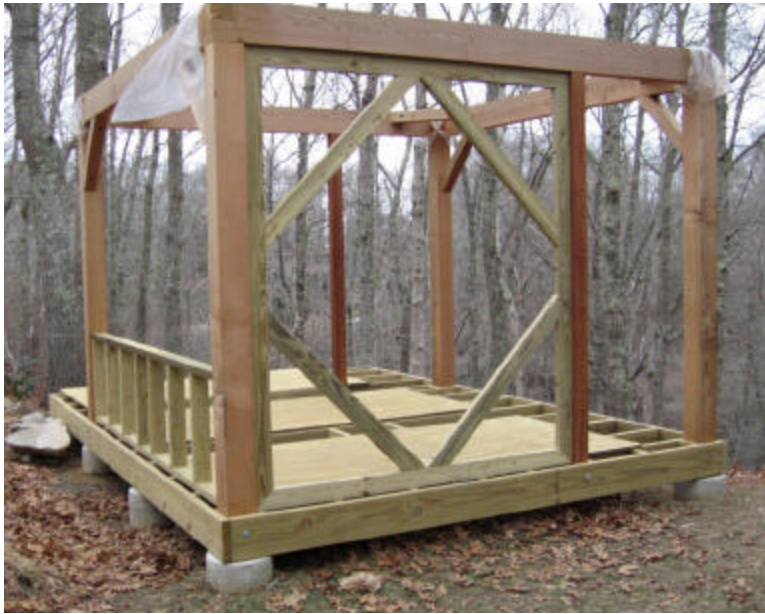
A cedar post & pressure-treated stress wall / frame (for a moon window), and 1/3 height wall (left, for moving screens) were installed, along with plywood flooring and another cedar post at the far end (for entry door & tokonoma alcove). The right side, overlooking a natural pond and dense woods, is to be left open for the time being (probably will have floor-to-beam screens).

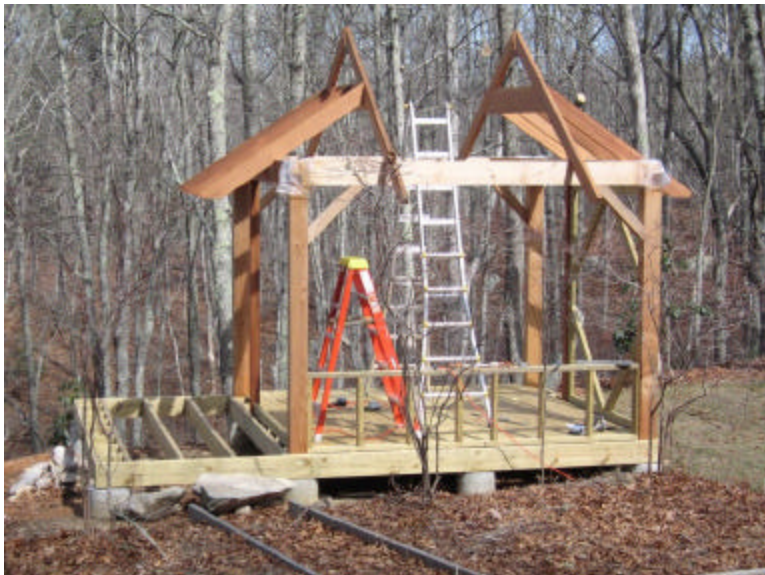
Two preassembled A-frame hip trusses were raised and then attached to 4 short rafters at either end. All were squared - up and lag-bolted to the post and beam frame.

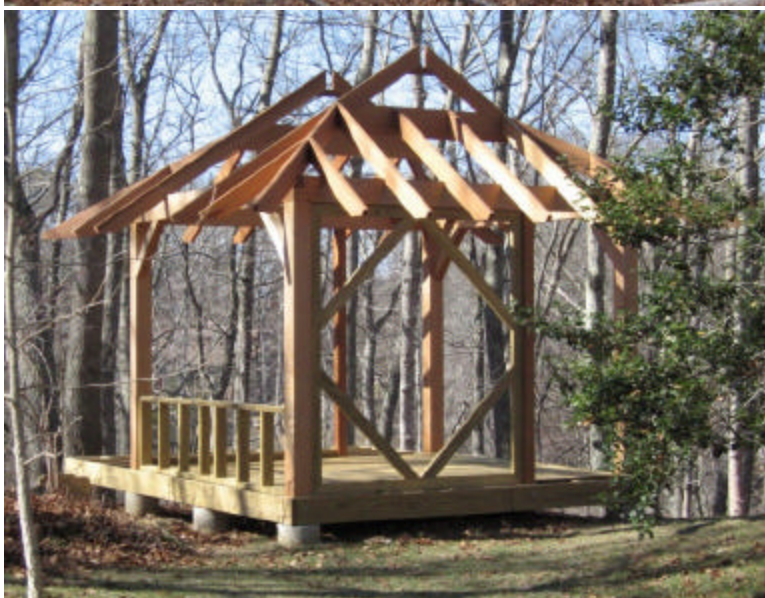
The hip rafters and adjoining corner jacks were then bolted in place, fully securing the two hip sections for later placement of the ridge beam between them, into the two notches at the top.

Two long rafters on each side, collar ties, small jacks and blocking will then finish the basic roof structure. Port Orford cedar will likely be the choice for sheathing.

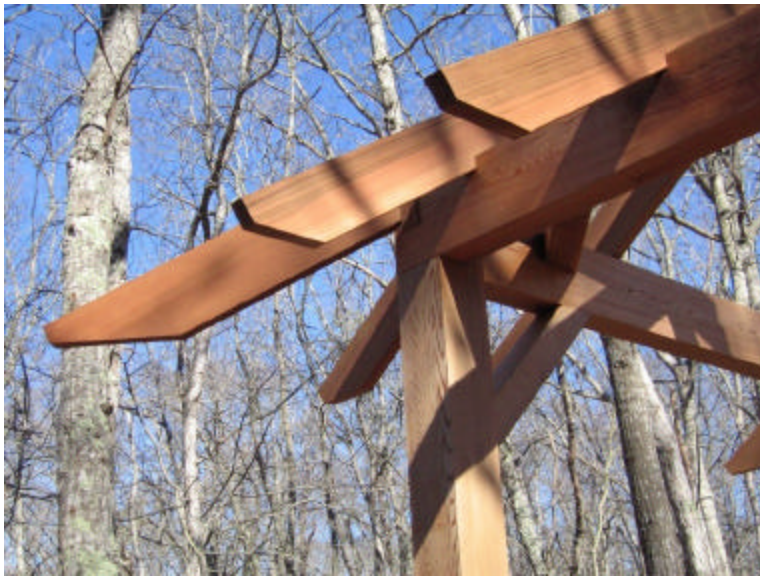
Corner construction, with post, half-lapped beams, and knee and dragon braces.

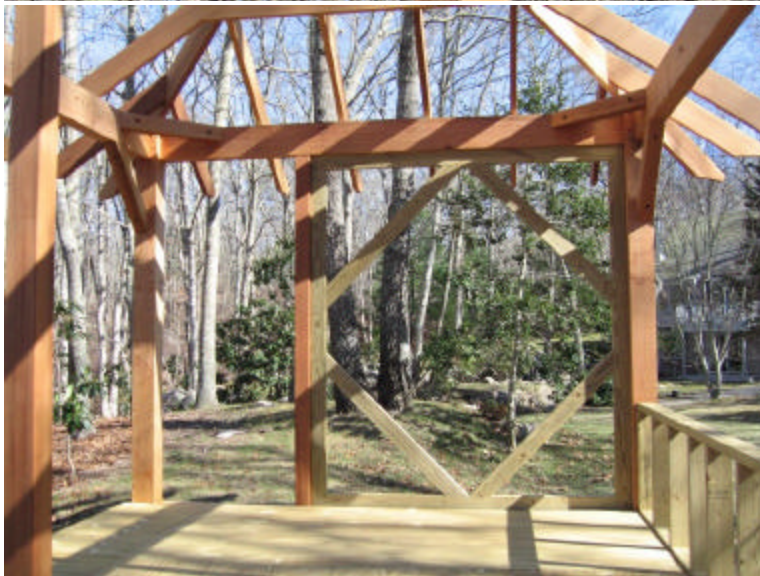
View from inside, toward moon window opening, back yard, and house.

Plywood floor will be eventually covered with 4 ½ tatami mats.
